## Advisory Notice for Titan T-51 Mustang Aircraft

March 6<sup>th</sup>, 2020

### Inspection required before any further flights

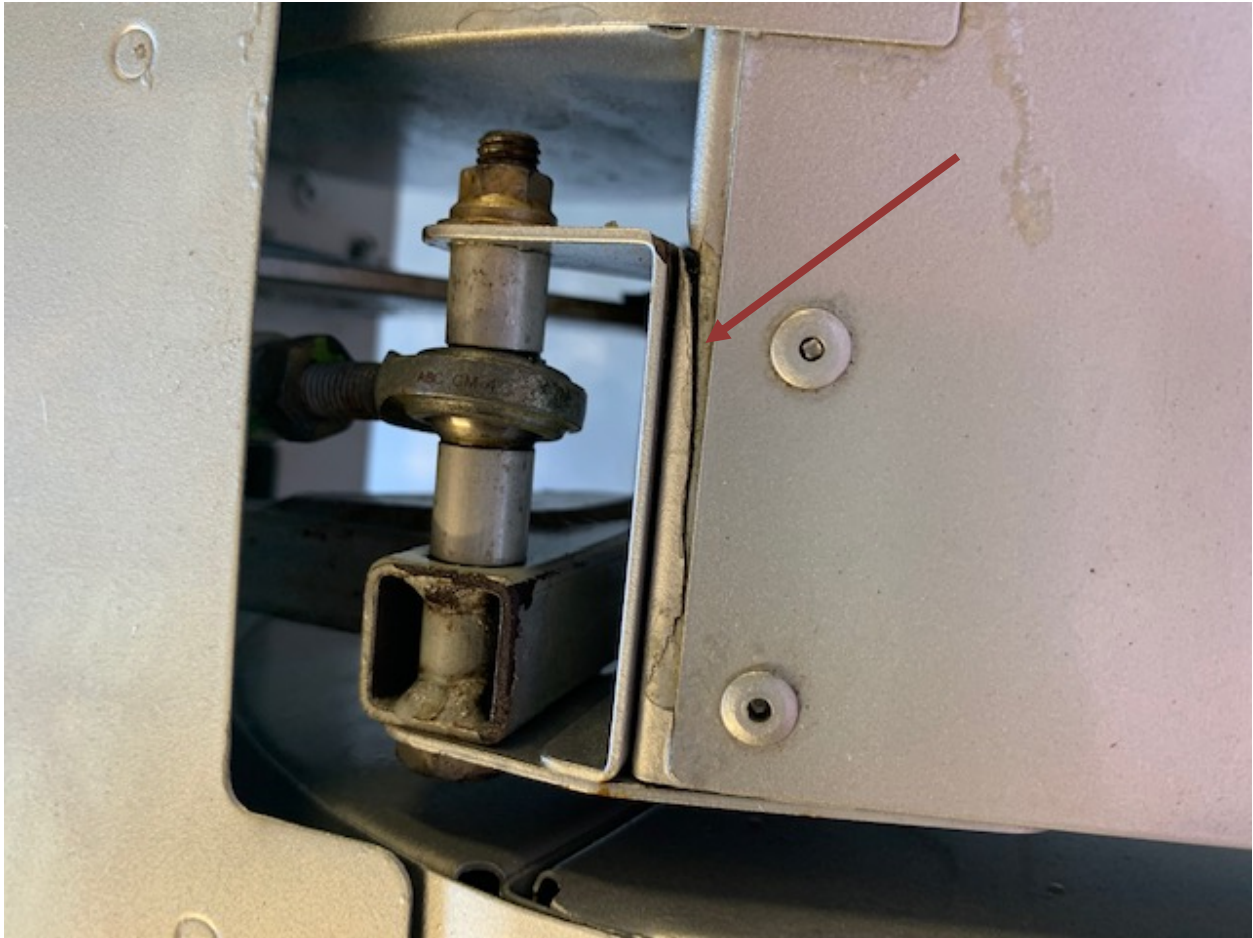
fig.1

**Aileron Spar cracks** near the **Aileron Driver Bracket**. Cracks were found in an aircraft with approximately 300 hours of total flight time

Every 100 hours, during an annual, or condition inspection, inspect the Aileron Spar near the driver bracket for cracks, as shown in FIG 1 and FIG 2. This area must be inspected thoroughly. If the Surface is painted inspect carefully to be sure there are no cracks, remove paint if necessary.

If a crack is found, the spar must be repaired or replaced before any further flights.
