Advisory Notice for Titan T-51 Mustang Aircraft

July 7, 2010

Inspection required before any further flights

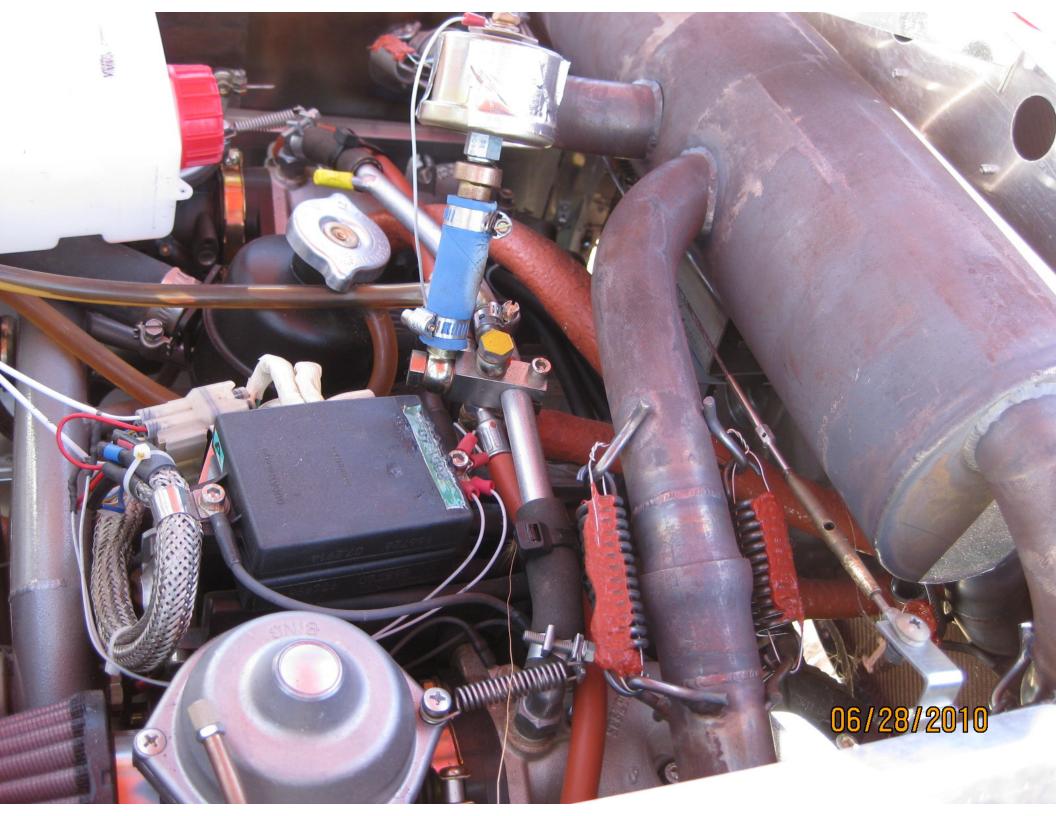
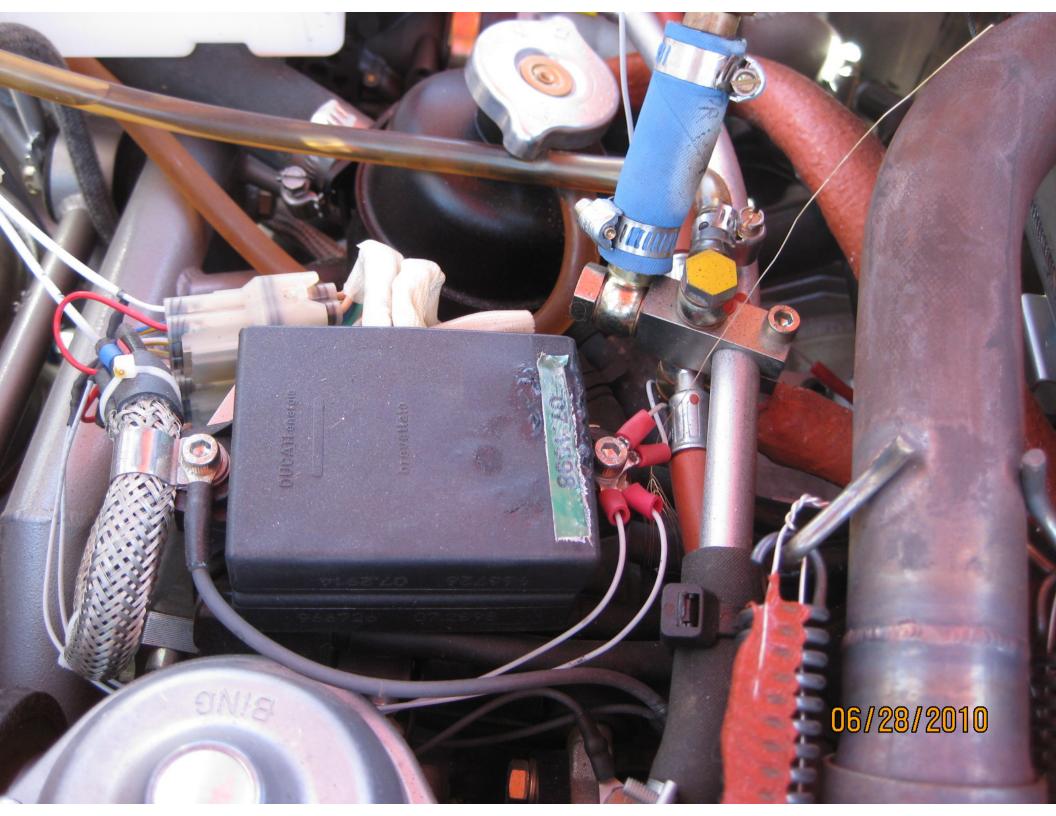
Ignition module failure can occur due to heat from the exhaust.

With the cowlings removed, closely inspect the ignition module and surrounding area for discoloration and/or melting of the plastic housing and wires.

Please see attached pictures for reference.

Installation of exhaust/header wrap on the muffler and outlet pipes or fabrication of a heat shield to cover the ignition module is required.

The heat shield can be constructed from stainless steel or aluminum. Note that the shield will have to be inspected regularly and replaced if it begins to crack.
