Advisory Notice for Titan T-51 Mustang Aircraft

March 4, 2009

Service recommended before any further flights

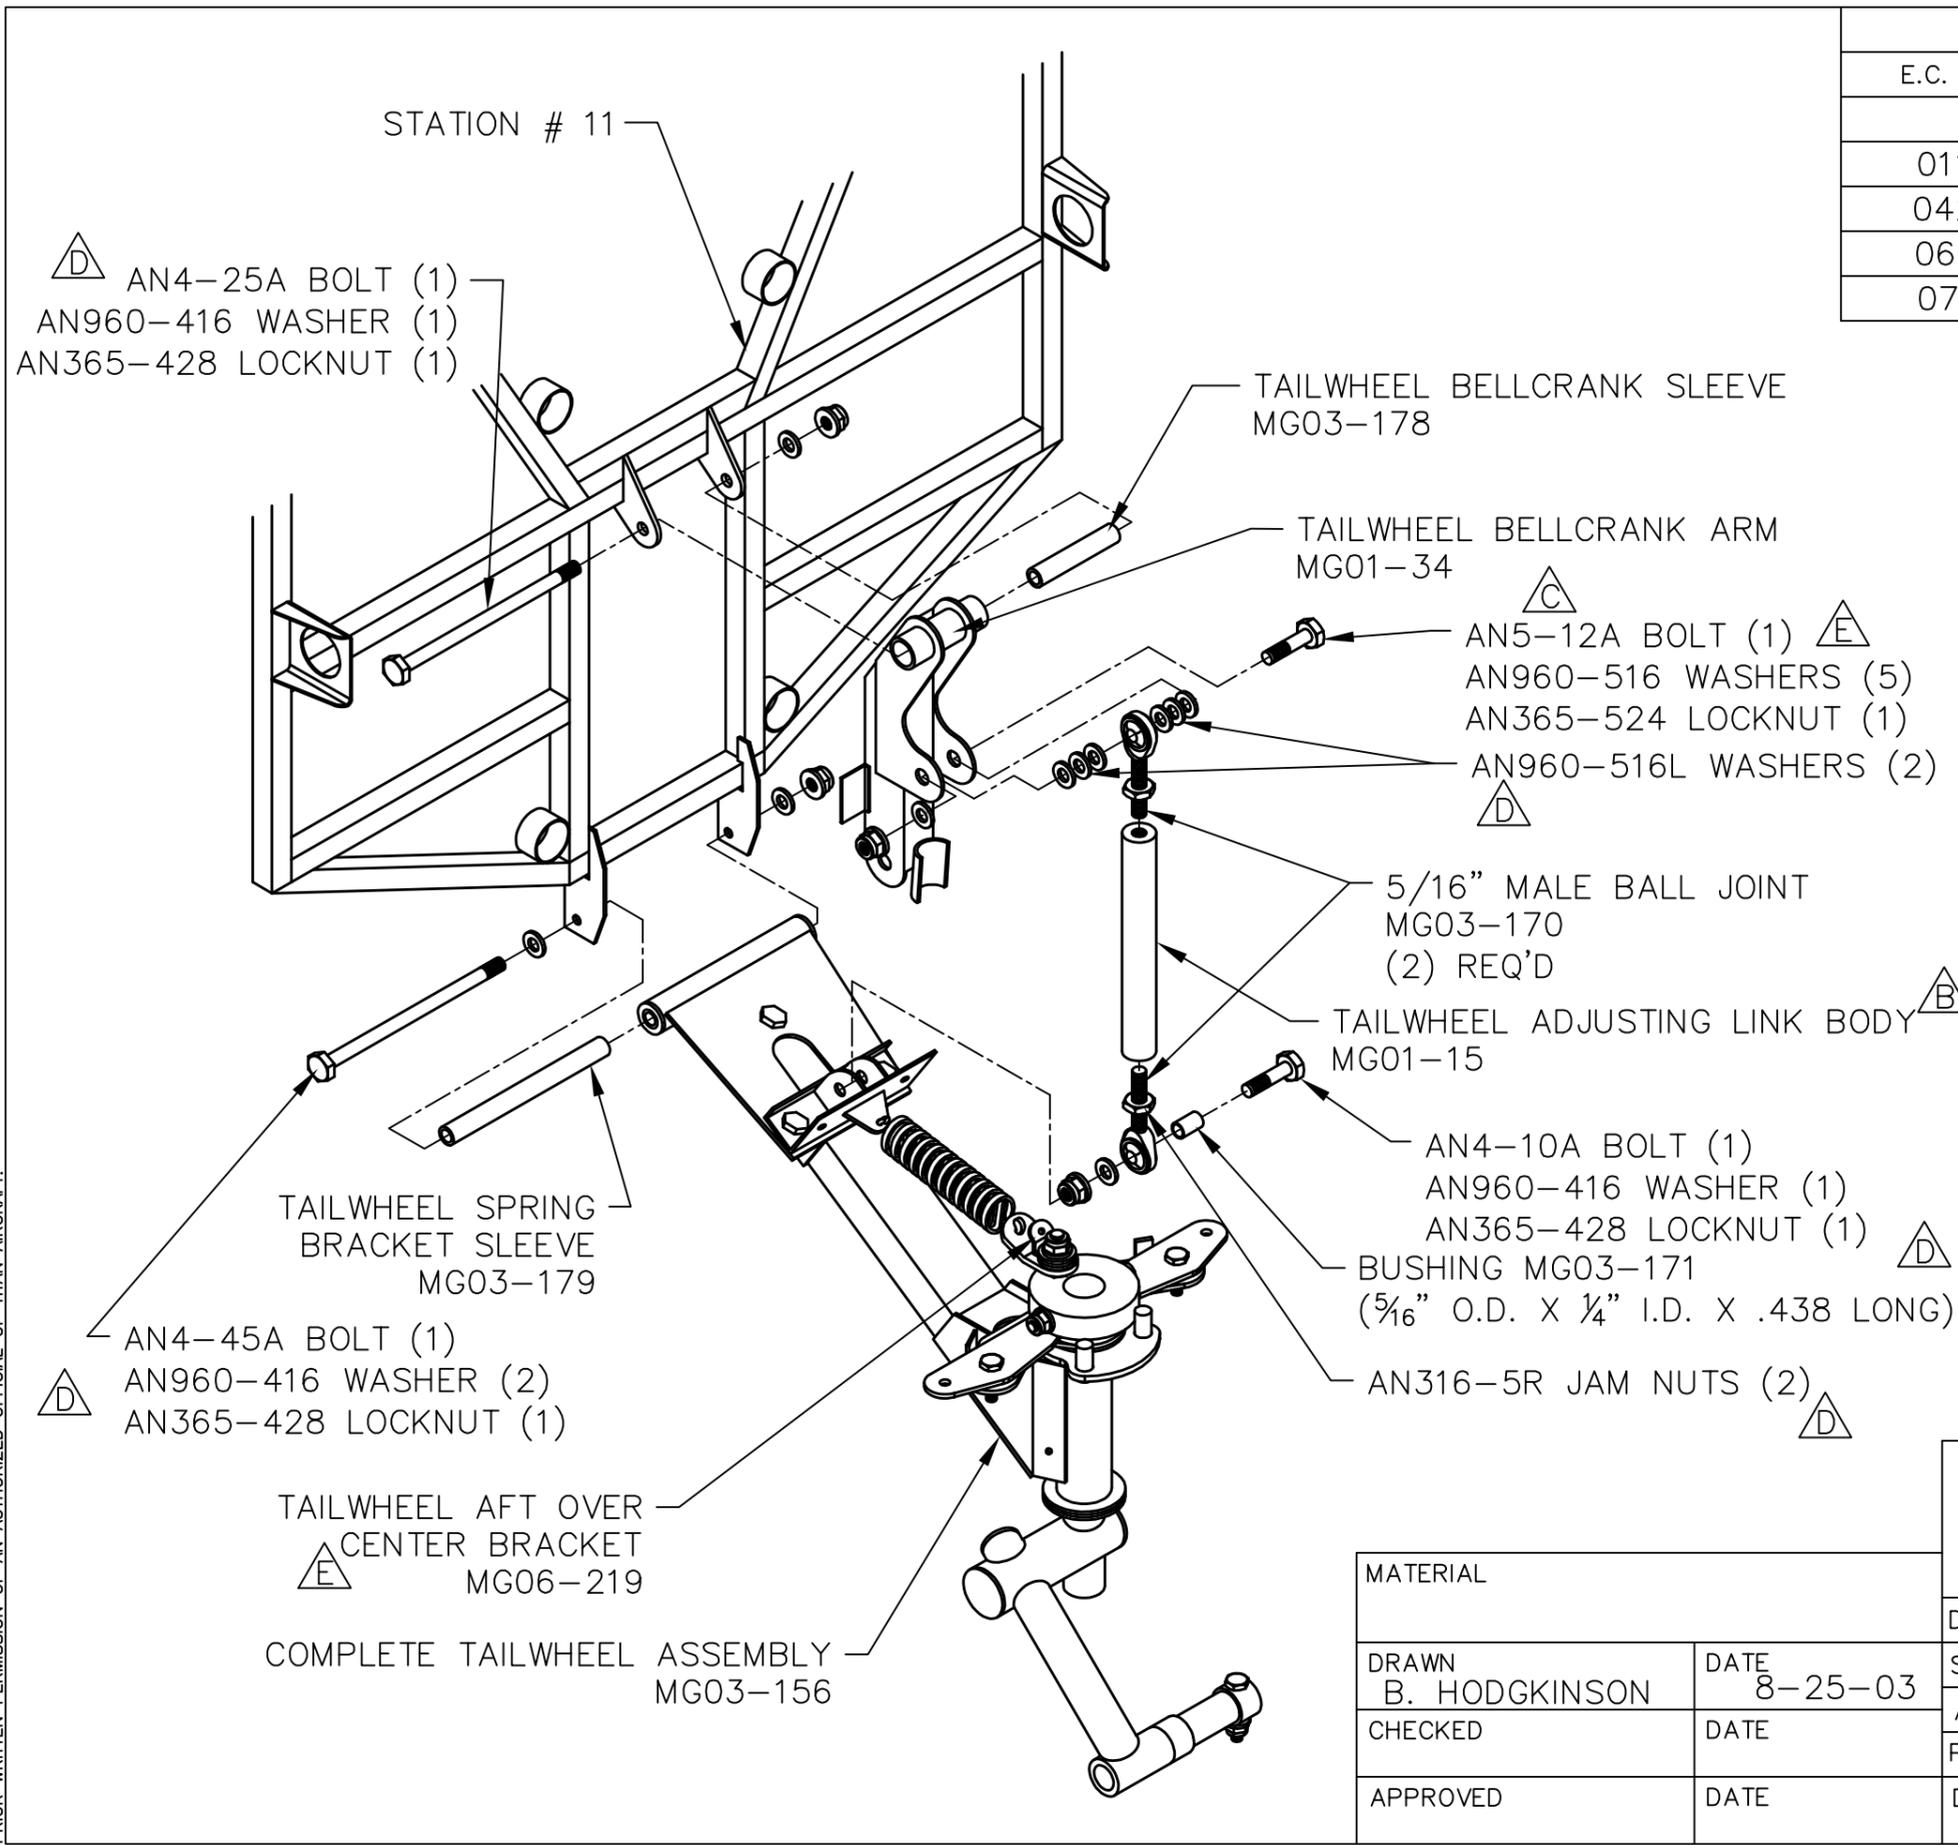
An aircraft, with approximately 150 hours of service on a rough grass field, was found to have the support tube at station #11 twisted. This caused the tailwheel to retract while the aircraft was landing, resulting in damage to the gear doors.

Using the aft baggage compartment opening, inspect station #11 to see if there is a second tube welded in place above the over center support bracket tube, as shown on the attached drawing number T51-03-INS-0816-E. If there a second tube no further action is required, if not, see below.
